Technical Bulletin / Safety Alert

Unique ID No: GEN2012-TBSA-02

Subject: Driftrunner Steering Valve Installation

Applicable to: All VLI Driftrunner Vehicles

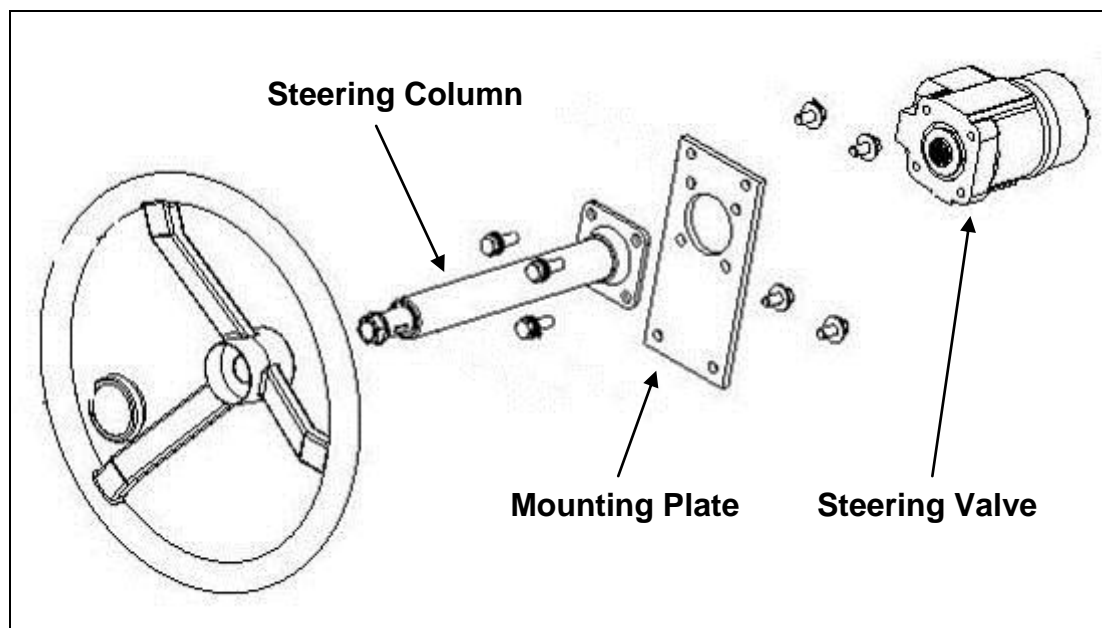
VLI Diesel Pty Ltd advises equipment owners and end users of a manufacturing installation issue affecting the Steering Column to Steering Valve assembly on recently manufactured Driftrunner vehicles.
