Technical Bulletin / Safety Alert

Unique ID No: DES2008-TBSA-01

Subject: Possible Engine Shutdown Cylinder Failure

Applicable to: VLI Diesel Driftrunners & Brumbies

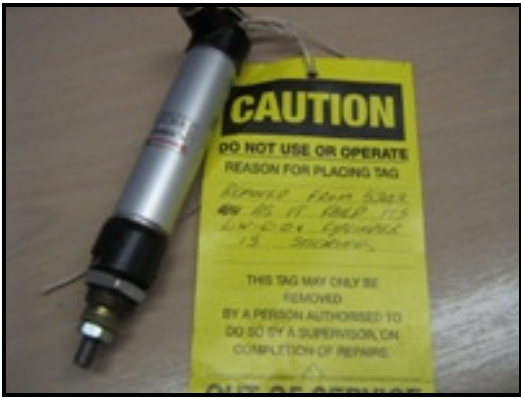
Figure 1.

A potential problem was reported to VLI Diesel regarding the operation of the fuel shut off cylinder fitted to VLI Diesel Driftrunners. VLI Diesel made some initial enquiries to the site to ensure that genuine OEM parts were the ones in question. I requested that one of the faulty cylinders be returned to VLI Diesel Tomago for inspection. I received that cylinder from site on Wednesday 27/8/2008 & proceeded to dismantle & inspect for this report, findings as follows:

It appears the cylinder failed to operate correctly due to contamination of the internal parts due to the ingress of foreign objects into the cylinder body. After dismantling, cleaning & lubrication of the shut off cylinder it functioned correctly without any signs of sticking whatsoever.

VLI Diesel recommends regular inspections/maintenance of all components fitted to the Drifrunner with particular attention to the pneumatic circuit, safety circuit & Engine componentry.
