## ENGINEERING BULLETIN

Ref Document No.	EB15007	Issue No.	1
Subject	Hydraulic Tank Level Sensor Pneumatic Tubing		
Release Date	10 <sup>th</sup> April 2014

**Purpose** – Advise COALTRAM® owners of areas of improvement

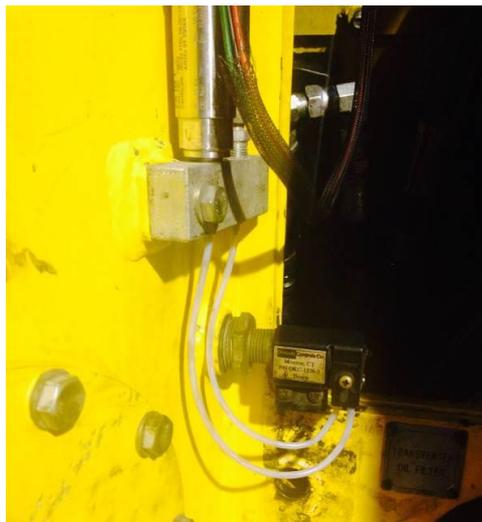
The FEP tubing used has a history of falling off the flared nipple to which it is connected.

PPK have had success using PTFE tubing as a replacement. PTFE has a higher temperature working range than the FEP tubing and is highly non-reactive.

*Figure 1: PTFE tubing installed*

1. PPK recommends replacing the existing tubing with the PTFE tubing (part No. 5520009568) when necessary.
2. Follow SWP to replace tubing.
3. The PTFE tubing (5520009568) is currently available from PPK.
