TECHNICAL BULLETIN

Ref Document No.	TB24001	Issue No.	1
Subject	JUG-A-0 Park Brake Valve Exhaust Vent Fitting		
Release Date	20 th February 2024

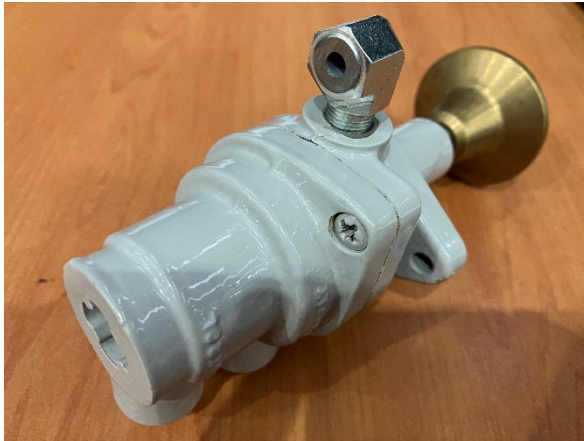
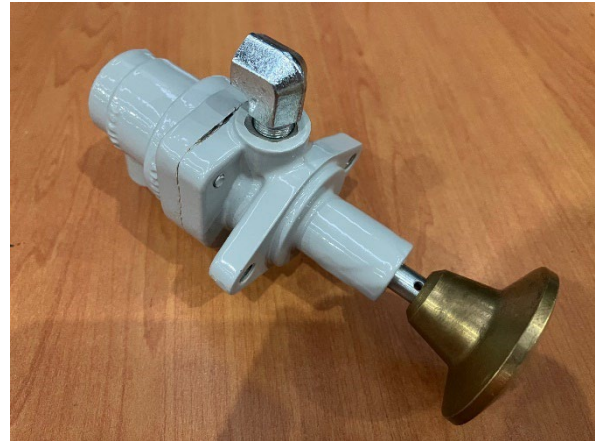
Park brake valve with open flow breather installed, a cut-off 90 degree fitting.

Therefore, due to this finding of accumulated O-ring material and to aid in preventing this situation from reoccurring, a less restrictive and more open flow exhaust breather fitting is recommended to be installed in the park brake valve exhaust port. The recommended breather fitting is shown in images on the following page.

1. Users should be aware of the potential for the sintered bronze breathers to trap material, which can create a hazardous situation where a trapped signal impairs the valve's function.
2. Install a less restricted flow thru breather fitting in the exhaust port of the park brake actuation valve. Initial recommendation for a suitable exhaust vent is installing a modified hydraulic fitting, a 7/16 JIC x 1/8 BSP 90° elbow fitting with the JIC end removed. Refer to photos above.
