# SAFETY BULLETIN

Ref Document No.	SB23002	Issue No.	1
Subject	JUG-A-0 Hydraulic Adjustable Canopy Incident		
Release Date	15 <sup>th</sup> December 2023

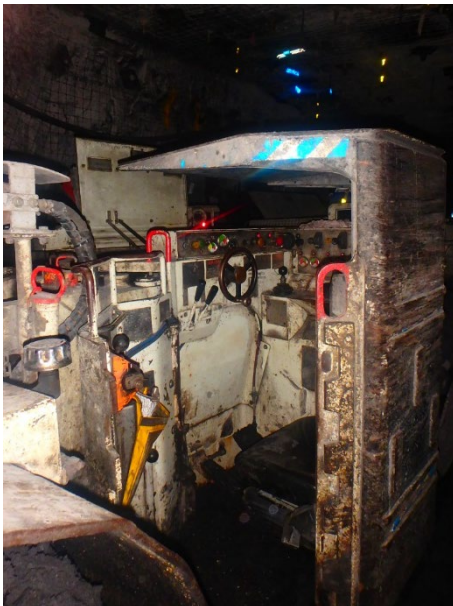
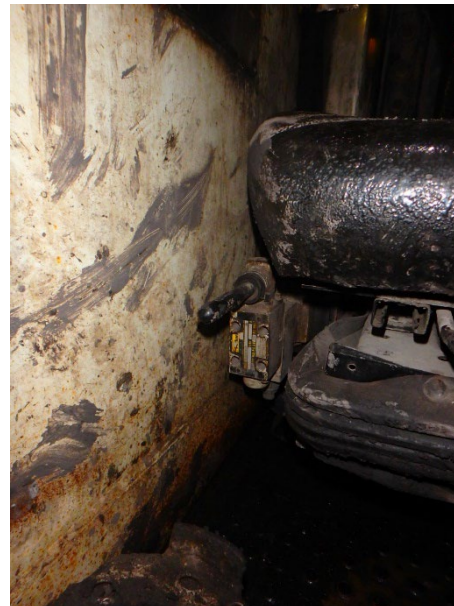
The vehicle involved in the incident was installed with a site-specific JIHAC accumulator system, which is only installed on the JIHAC low height version. The accumulator system allows the canopy to be moved with the engine off.

While elevated and leaning over the dash to investigate the pneumatic fault, the tradesperson inadvertently stepped on the canopy control valve lever located beside the seat, lowering the canopy onto themselves. The tradesperson was trapped and unable to reach the lever, then called for assistance. The operator nearby quickly reached into the cabin and raised the canopy, releasing the tradesperson.

1. The following controls should be implemented:
  - a) Guarding around the canopy control lever.
  - b) Two-handed operation of the canopy control.
  - c) Crush zone labelling.

2. Maintenance tasks requiring people to be under the canopy should be conducted with the hydraulics isolated and mechanical stops installed. For low-height JIHAC systems which include an accumulator, this means de-energising the accumulator via the main air isolation valve prior to maintenance tasks.
3. Sites should review training of operators and tradespersons in the proper isolation of the vehicle. Information on vehicle isolation can be found in the OEM service manuals.
4. Until such time that the controls identified in item 1 are in place, alternative controls should be implemented (with consideration to those identified in this bulletin and the referenced safety alert).
