Technical Bulletin / Safety Alert

Unique ID No: GEN2015-TBSA-02

Subject: JUG-A-0 Tilt Cylinder Failure

Applicable to: All JUG-A-0 UL/UV Machines

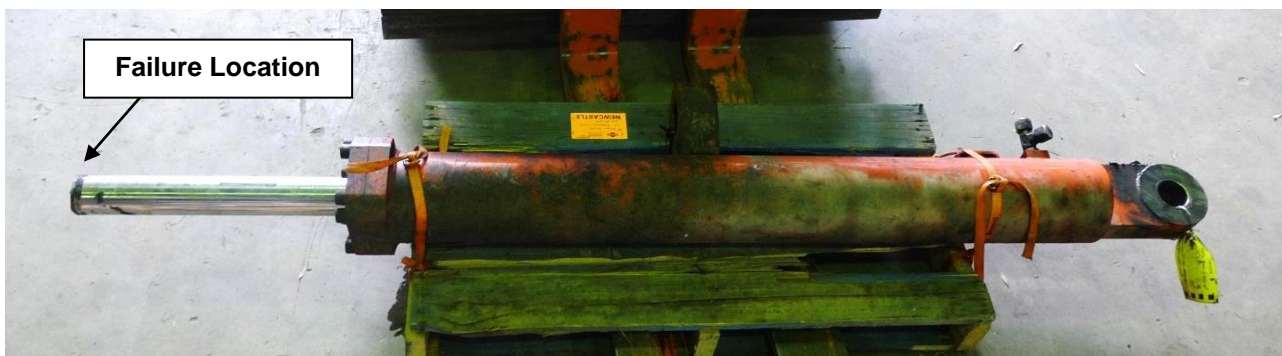
A JUG-A-0 Tilt (crowd) cylinder (Part Number 0308-10001) failure occurred recently in a NSW coal mine. The failure occurred through the tilt cylinder rod adjacent to the attachment clevis connected to the MIS (Multi Implement System) Plate and resulted in an uncontrolled lowering of the implement. There were no injuries to personnel.

An independent failure investigation was completed with regards the tilt cylinder rod failure, which found "*Failure of the tilt cylinder rod occurred by brittle fracture at the toe of the clevis weld as a result of multiple shock loading events to the component. The fracture had originated from a pre-existing crack within the weld toe region through the heat affected zone*" of a previous weld repair.

1. Tilt cylinder rod and barrel clevises should be included in the Mine/Operator NDT assessment program. VLI recommends a visual inspection on a daily basis and an NDT inspection every 1000 hours.
2. Cracks identified during NDT assessments must be repaired or the tilt cylinder replaced. Welding repairs to the tilt cylinder are not recommended in-situ and should be returned to VLI for repair or replacement.
3. Use of non OEM tilt cylinders is not recommended.
4. Use of VLI approved MIS attachments/implements on JUG-A-0 UL/UV machines is recommended.
