## **Technical Bulletin / Safety Alert**

**Unique ID No:** DES2013-TBSA-01

**Subject:** JUG-A-0 Machine Shutdown System – Methane Bypass Switch Box

**Applicable to:** All JUG-A-0 UL/UV Diesel Engine System Design Registration Nos.  
MDR074246DES, MDR074246DES-1 & MDR114991DES

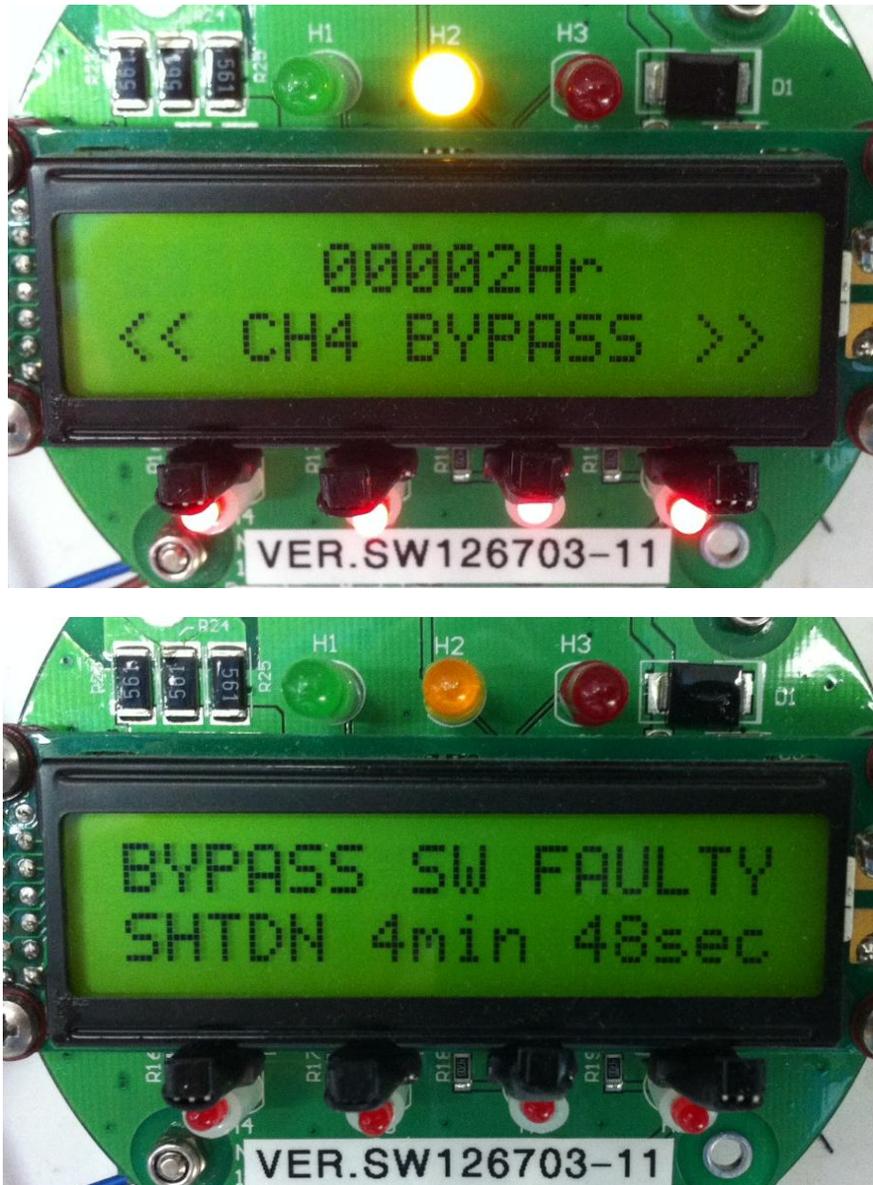
VLI can confirm that in the event of a methane bypass switch fault the methane monitoring system display provides indication, and will display either the message ‘ch4 bypass’, indicating the machine is operating with the methane monitoring function bypassed, or the message ‘bypass switch fault’ as shown in Figure 1 below. When a ‘bypass switch fault’ is displayed, the system will begin a 5 minute countdown before going to automatic shutdown.

**Figure 1:** Photographs showing the JUG-A-0 Shutdown System Display when in “ch4 bypass’ mode or when a “bypass switch fault’ is detected.

In the event of a methane bypass switch fault the methane monitoring system display provides indication, and will display either the message 'ch4 bypass', or the message 'bypass switch fault'.
