## **Technical Bulletin / Safety Alert**

**Unique ID No:** DES2011-TBSA-01

**Subject:** Bypassing the JUG-A-0 UL/UV Diesel Engine Shutdown System (Nautitech)

**Applicable to:** All JUG-A-0 UL/UV V2 & V3 Machines

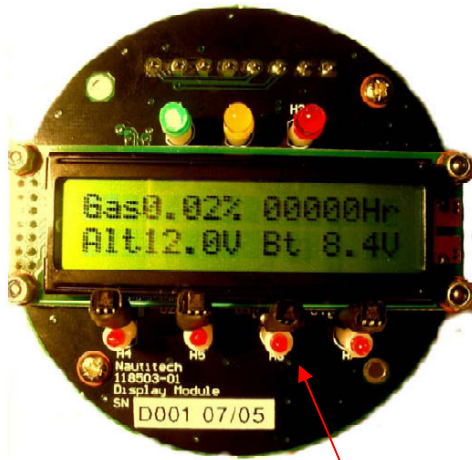
**Juganaut System – Quick Reference Guide Rev B**

<b>CH4 BYPASS</b>	Engine has been Turned On in Bypass Mode and system will operate regardless of Gas level. Note: Temperature sensors will continue normal operation regardless of Bypass Switch state.
<b>AIR SOL FAULTY</b>	Air Solenoid Open Circuit has been detected. Check Coil Resistance – nominal 22R. Check Wire 19 and 17 to the Solenoid
<b>AIR SW/SUPP FLT</b>	Air Switch or Air Supply is Faulty. Alternator Voltage detected but Air Switch indicates Open Circuit
<b>CHECK ISOL SW</b>	Check if Isolator Switch is not in Isolate Mode. Alternator Voltage detected but Battery Volts is at DV. This can also indicate faulty Battery.
<b>SYSTEM OFF TURN AIR OFF</b>	CH4 System has been trying to turn Battery Power Off but Air Circuit is holding Battery in the On state. This could also indicate Faulty (Always On) Air Switch
<b>ALL COMMS FAULTY</b>	Indicates lost Comms between Display, Sensor & Charger. Most likely short circuit between wires CAN+ and CAN-

<b>CHARGER COMM ERR</b>	Indicates lost Comms between Display & Charger. Most likely Open Circuit on CAN Bus or faulty Charger PCB
<b>CH4 HEAD COMM ERR</b>	Indicates lost Comms between Display & CH4 Head. Most likely Open Circuit on CAN Bus or Faulty CH4 Head PCB
<b>BATTERY V. LOW</b>	Indicates that the Battery is fully discharged. Restart Machine in Override Mode and allow min. 15 min for batt. to charge. Observe Batt Volts on LCD
<b>SENSOR PROTECTED</b>	Indicates that level of CH4 at the sensor exceeded 3.5% and Power to the Sensor has been turned Off to protect it's circuitry. Turn Air Off, Check CH4 level and restart.
<b>REPL CH4 SENS&gt;en</b>	Indicates that Internal Fault has been detected within CH4 Sensor. Replace sensor and return faulty sensor to manufacturer.
<b>← CH4 TRIP → REQ DEPUTY RESET</b>	Deputy has to Reset CH trip by following: 1. Remove Lock from Deputy Override Switch 2. Move Switch to Override Position 3. Start the Engine 4. Place Switch back to Normal position 5. Replace Lock on the Switch

LEDs  
Flash

- TEMPERATURE WARNING**  
At least one Temperature Sensor detected temperature above 82 deg C
- TEMPERATURE TRIP**  
At least one Temperature Sensor detected temperature above 85 deg C
- TEMP SENS# FAULT**  
Indicates open or short circuit of Temperature Sensor.  
Note: Temp Sensor cannot be measured with Ohm meter. Turn System On and measure voltage across sensor. Should be around 5V
- AIR BYPAS !!!**  
Internal Solenoid is Off but Engine has been started.  
Indicates that Air Shutdown circuit has been bypassed
- BYPASS SW FAULTY**  
Indicates that wire to Bypass switch is either short or open circuit. Alternatively resistors inside junction box are incorrectly connected.

**AIR BYPAS !!!**

Internal Solenoid is Off but Engine has been started.  
Indicates that Air Shutdown circuit has been bypassed

It should be noted that when the air solenoid in the Nautitech system is bypassed, a message to this effect will be displayed on the Nautitech display and the four (4) lower LEDs on the display will flash simultaneously every 10 seconds, refer supporting documentation.
