Technical Bulletin / Safety Alert

Unique ID No: GEN2008-TBSA-02

Subject: Selector Valve

Applicable to: Driftrunner fitted with a hydraulic crane

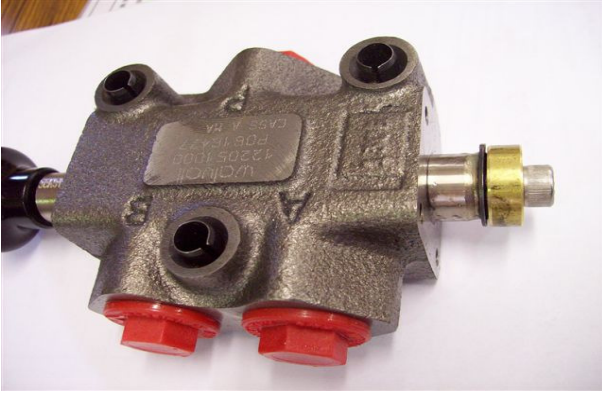
Whilst manually disengaging the crane selector valve on a Driftrunner fitted with a hydraulic crane, the bottom circlip became dislodged allowing the shaft to be removed from the valve body.

Corrosion or excessive force applied to the valve may cause the circlip to dislodge.

To prevent a reoccurrence a stop has been fitted to the bottom of the shaft as per photo below.

If you currently have a Drifrunner fitted with a hydraulic crane could you please contact your VLI Diesel representative to organise fitment of an upgraded valve or any additional information required.
